Manhole Inspection Summary

Manhole # S63G__028MH

Location Address: **5100 Mason Lord Dr.**

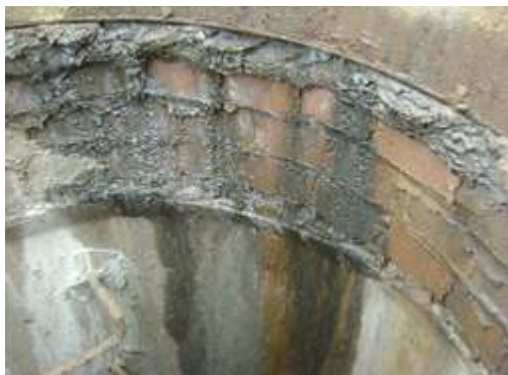
Defect 3

INFILTRATION

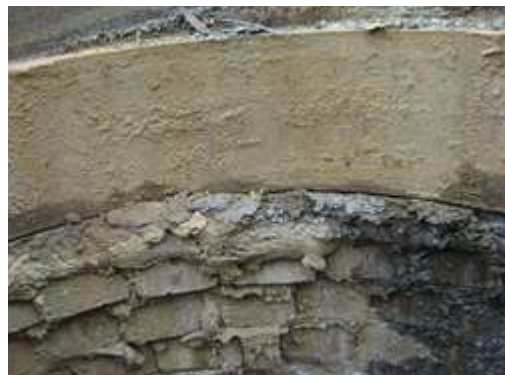
Defect 2

Condition: ☐ Sound ☐ Cracked ☐ Root Intrusion ☐ Loose Brick ☒ **Deteriorated**

Deteriorated mortar under frame seal

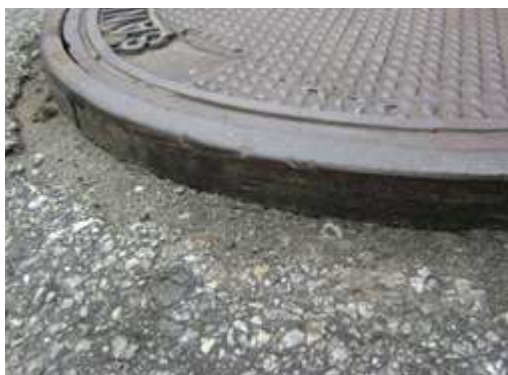
Defect 1

frame is 1inch above grade - in roadway

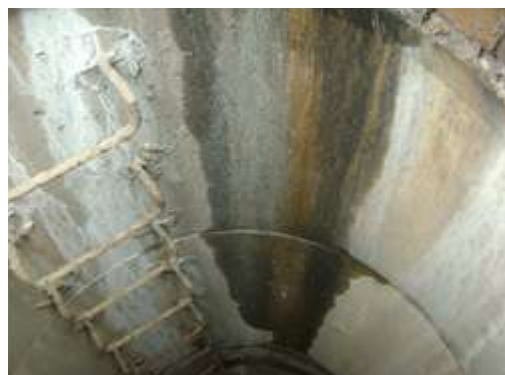
Defect 4

Infiltration: ☐ None ☒ **Joint** ☐ Cracks ☒ **Mortar** ☐ Roots ☐ Wall

infiltration from chimney defect

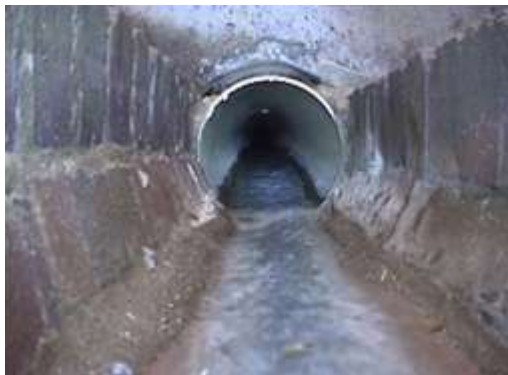
Defect 5

Broken pipe seal 11:00 on outgoing 12

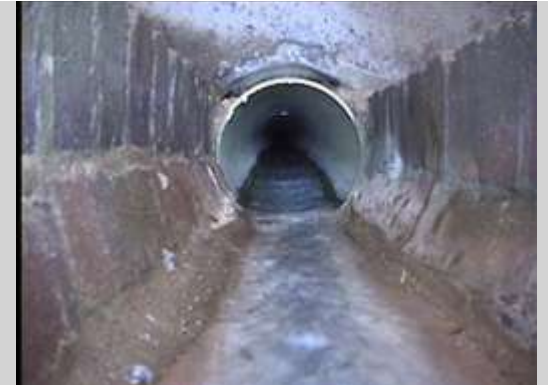
12 O'Clock Outflow

Pipe Height: **8.4** (in.) Rod and Bar (Angled)
Pipe Material: **PVC** ☐ Pipe Lined
Invert Depth: **11.25** (ft.) Flow Characteristics: **Fast**
Deposits: ☒ None ☐ Mud ☐ Sludge ☐ Debris ☐ Grease
Silt Depth: (in.) Deposits Extent:
Infiltration: **None** Pipe Seal Cond: **Broken**

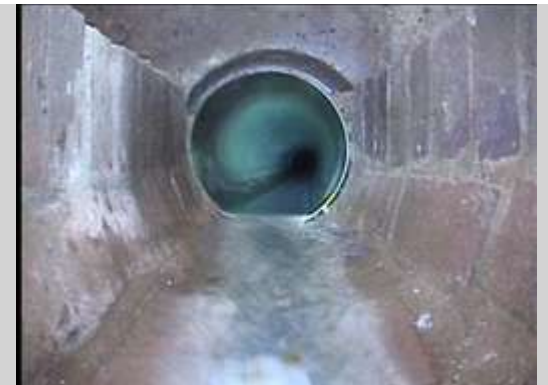
6 O'Clock Inflow

Pipe Height: **8.4** (in.) Rod and Bar (Angled)
Pipe Material: **PVC** ☐ Pipe Lined
Invert Depth: **11.08** (ft.) Flow Characteristics: **Fast**
Deposits: ☒ None ☐ Mud ☐ Sludge ☐ Debris ☐ Grease
Silt Depth: (in.) Deposits Extent:
Infiltration: **None** Pipe Seal Cond: **Sound**
